## A Foreign Material Image In The Coronary Sinus During Coronary Sinus Angiography

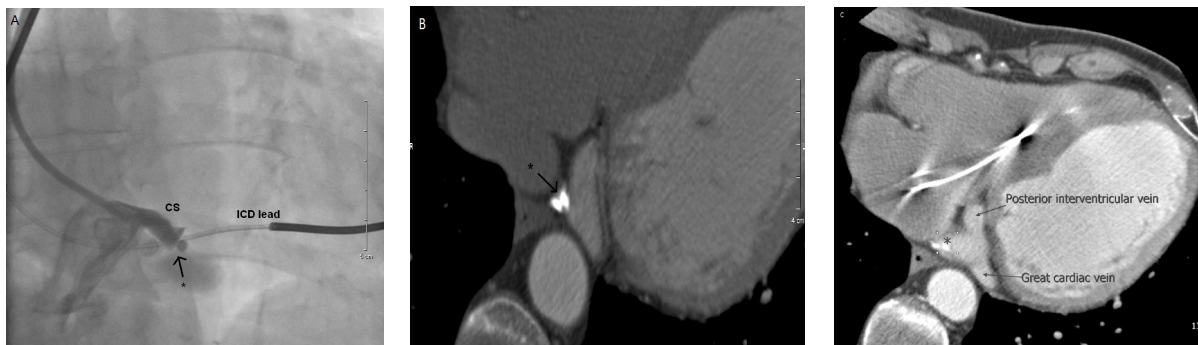
A 63-year-old man with history of bedside temporary pacemaker lead insertion a year ago was hospitalized for cardiac resynchronization and defibrillator device implantation. After insertion of the right ventricular shocking lead we tried to engage the ostium of the coronary sinus (CS) and injected some dye to delineate its anatomy. Unfortunately, the proximal portion of the main CS was occluded. In addition, 2 fixed and rounded neighboring foreign materials were incidentally detected within its opacified portion (Fig. 1A, arrow indicates foreign material). A subsequent multislice computed tomography (Fig. 1B, Fig. 1C \* indicates foreign material) confirmed

CS occlusion and foreign metallic materials (Hounsfield unit: 2686) resembling metallic electrodes most probably originating from the previous inserted temporary pacemaker lead. We suggested that the forceful blunt insertion of the firm lead tip dissected the CS wall and created a subintimal pouch. Further blood accumulation and formation of intense coagulum externally compressed the wall and occluded the lumen of the CS. When the temporary pacing lead that was partly encapsulated and fixed by the fibrocoagulative tissue was forcefully pulled out, the metallic electrodes overlying the lead tip might have been torn off and retained within the CS. This interesting and rare case highlights an unusual cause of CS occlusion

**Figure 1:** A foreign material was seen in the coronary sinus angiography (Fig. 1A). A subsequent multislice computed tomography confirmed CS occlusion and foreign metallic materials (Fig. 1B, Fig. 1C; \* indicates foreign material)

and unexpected complication of temporary pacemaker lead insertion. One must be sure that no fragments have been retained or embolized when removing the pacing leads from the body.<sup>1</sup>
