## Successful Denovo Implantation And Explanation Of An Old Malfunctioning Micra™ Leadless Pacemaker

The use of leadless pacemakers is rapidly expanding. There is limited experience of extraction of leadless pacemakers. This case describes the successful extraction of an underperforming leadless pacemaker several weeks after initial implantation.

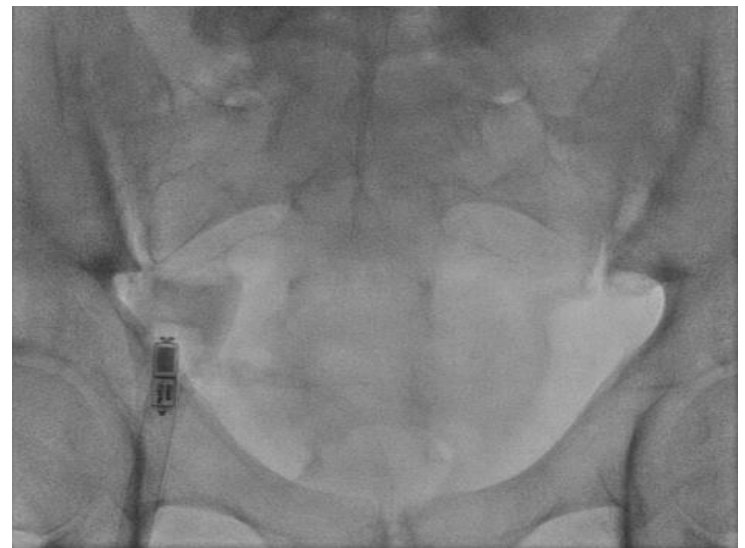
**Figure 5:** Leadless pacemaker entrapped in the hemostatic valve of the delivery sheath

This image shows the entrapped leadless pacemaker just beneath the hemostatic valve of Leadless pacemaker sheath.

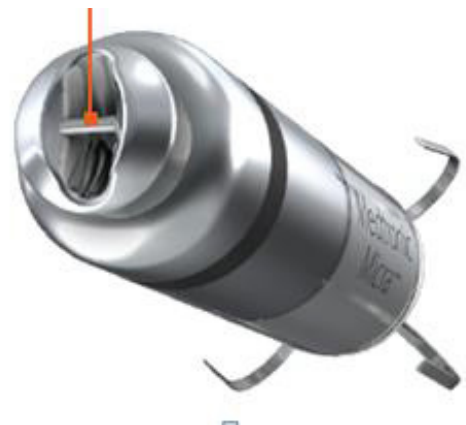
**Figure 6:** Proximal retrieval feature of the device

This image shows the proximal retrieval feature of leadless pacemaker for deployment of snare. The sheath is outside the body and is upside down.

proximal retrieval feature of the device (Figure 6). This proximal feature allows the distal cup of the delivery catheter to completely cover the proximal retrieval mechanism of Micra™. Once the delivery cup is snugged on the proximal part of the leadless pacemaker, the device is withdrawn from the tissue into the sheath. However,
